DEPARTMENT OF TRANSPORTATION

Contract #: 04-0120F4Cty: SF/ALA Rte: 80 PM: 13.2/13.9File #: 69.28**WELDING INSPECTION REPORT****Resident Engineer:**Siegenthaler, Peter**Address:** 333 Burma Road**City:** Oakland, CA 94607**Report No:** WIR-024415**Date Inspected:** 31-May-2011**Project Name:** SAS Superstructure**OSM Arrival Time:** 1500**Prime Contractor:** American Bridge/Fluor Enterprises, a JV**OSM Departure Time:** 300**Contractor:** Zhenhua Port Machinery Company, Ltd (ZPMC), Changxing Island **Location:** Shanghai, China**CWI Name:** Mr. Sha Zhi**CWI Present:** Yes No**Inspected CWI report:** Yes No N/A**Rod Oven in Use:** Yes No N/A**Electrode to specification:** Yes No N/A**Weld Procedures Followed:** Yes No N/A**Qualified Welders:** Yes No N/A**Verified Joint Fit-up:** Yes No N/A**Approved Drawings:** Yes No N/A**Approved WPS:** Yes No N/A**Delayed / Cancelled:** Yes No N/A**Bridge No:** 34-0006**Component:** OBG Segment Assembly**Summary of Items Observed:**

Trial Assembly / OBG Segment 14W

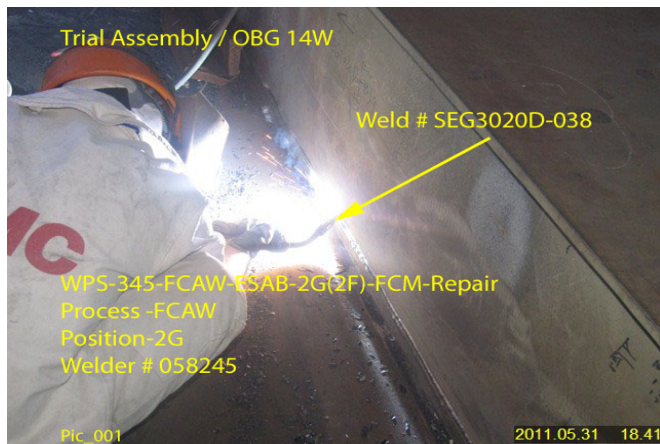
Flux Core Metal Arc Welding (FCAW) in the 2G position of repair weld # SEG3020D-038, as per B-CWR # 2997.

The welder is identified as 058245. ZPMC Quality Control (QC) is identified as An Qing Xian. The welding variables recorded by QC appeared to comply with WPS-345-FCAW-ESAB-2G(2F)-FCM-Repair. See attached photograph Pic_001.
